CJA Marine Services - Singapore & Thailand

16 MARCH 2009

HATCH COVERS - LEAKAGE & TESTING

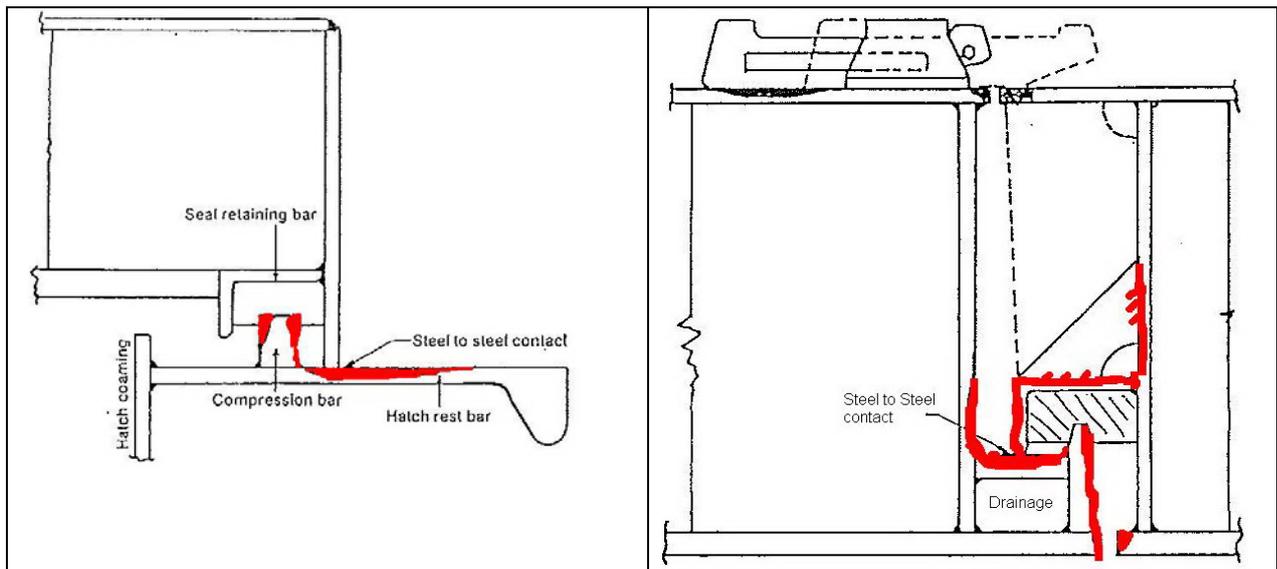
One of the most common causes of water ingress is attributable to lack of maintenance and corrosion. Below are the typical areas of corrosion found on hatch covers:-

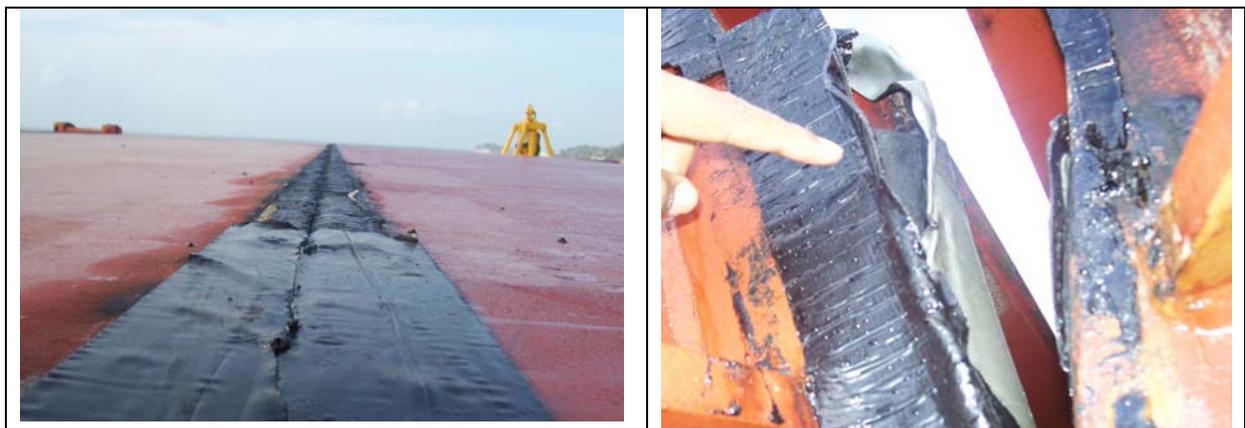
The use of sealing tapes or “Ram Nek” tapes at the cross joint of the hatch covers is common sight and some Shipper or Charterer have specifically insist to use them.

Seemingly, it looks like an additional precaution to enhance weathertightness. However, there are negative aspects to using hatch cover sealing tapes which include:-

- The adhesive tape cannot fully seal the hatch joint surface area due to the presence of cross-joint cleats or other uneven fittings
- The adhesive tape can wash off in heavy seas
- The adhesive tape can obstructed drain holes trapping water in the cross joint

- After usage, the removal of the adhesive tapes may eradicate the necessary coatings on the steel structure thereby exposing a higher risk of corrosion
