CJA Marine Services - Singapore & Thailand

ON DECK CARGO WASHED OVERBOARD AND LESSON LEARNED

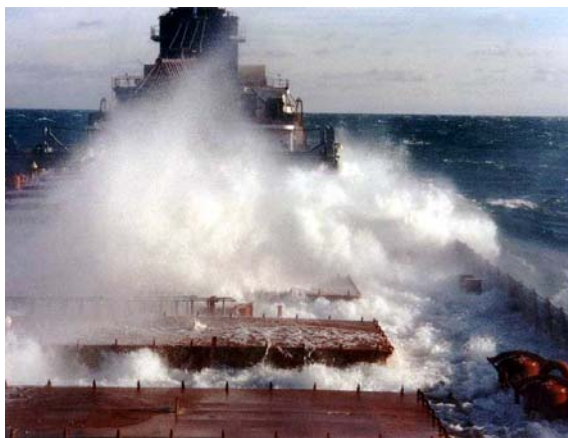
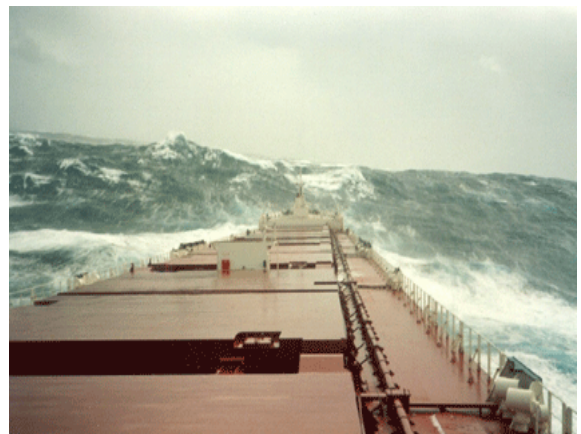
Pictures tell a thousand words and below are pictures depicting of a slight to moderate heavy sea conditions taken by seafarers. The condition of the sea during an ocean voyage can be very unpredictable and even more severe than what are shown below.

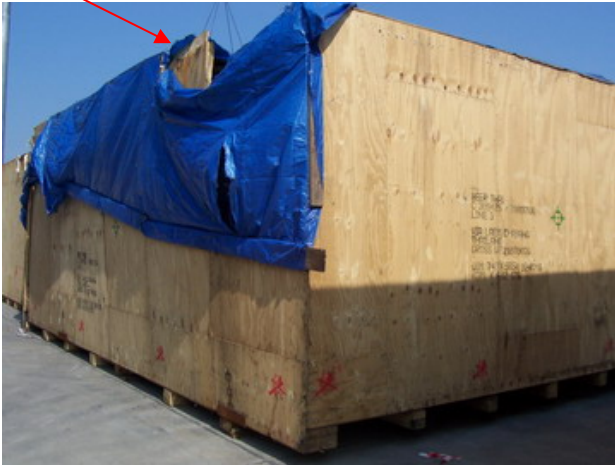
After our discussion with the Master, we proceeded to inspect the cargoes on board and noted that **one (1) wooden case was missing**. Its broken wooden planks were not sighted. Three (3) wooden cases stowed on No. 2 hatch covers were partly broken. Seven (7) wooden cases were partly broken at the edges / side. The remaining two (2) wooden cases were in an apparent sound condition.

Case broken and tarpaulin mostly torn

According to an extract taken from “*Lashing and Securing of Deck Cargoes*” published by M/s The Nautical Institute, page 2 and 3, Application of Lashings, were explained as follows:- We quote

*“The seaman’s rule of thumb for securing cargoes with a tendency to move during the voyage is simply that the sum of the minimum breaking loads of all the lashings should be **NOT** less than **twice** the static weight of the item of cargo to be secured. That is, a single case of 10 tonnes requires the lashings used to have a total break-load of not less than 20 tonnes on the assumption that the lashings are all positioned in a balanced, efficient, and non-abrasive manner. This rule may be adequate, or even too much, below decks - though not necessarily so in all instances - but it will be adequate on the weather-deck only in instances where a fair weather passage can be guaranteed. As this paper is concerned with the more likely sea-going circumstances where, for at least part of the voyage, winds of Force 6 and upwards together with the wave heights associated therewith are likely to be encountered, the stresses arising therefrom are those here considered.*”

*In such cases, the sailor's rule-of-thumb tends to be that the **sum of the safe working load** of all the lashings shall equal the static weight of the cargo item to be secured; the safe working load being arrived at by dividing by three 3 the minimum break or slip-load. In other words, if the break/slip load of all the lashings is 30 tonnes, then they can safely hold an item whose static weight is 10 tonnes. The author is not aware of any failures of lashings or loss of deck cargo where this rule-of-thumb has been applied in a balanced manner."*

Deck cargoes, because of their very location and the means of which they are secured, will be subjected to velocity and acceleration stress greater, in most instances, than cargo stowed below deck. Unlike under deck cargo cargoes which are protected by shell plating, framing or bulkhead, deck cargoes have **little** or **NO** protection against the vessel rolling, pitching and heaving during the sea passage. There are six (6) movements during a sea conveyance as shown in the picture below.

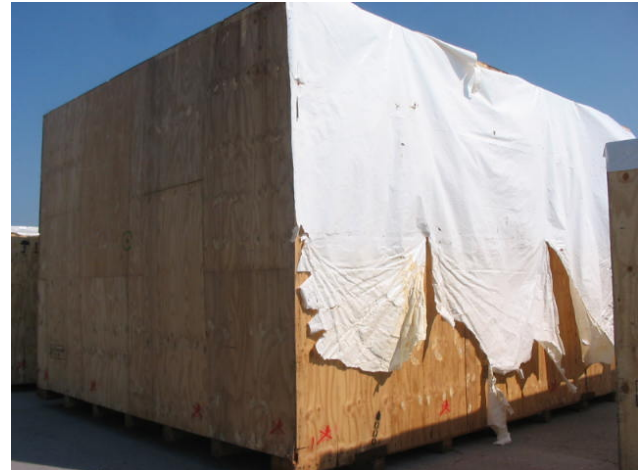
Case with tarpaulin mostly torn

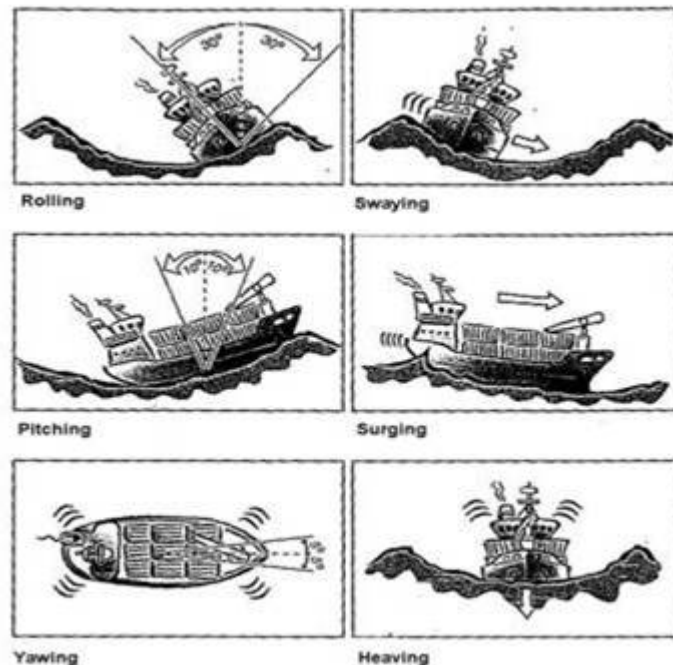
Movement of vessel during sea passage
